Video Analysis of Motorcycle and Rider Dynamics During High-Side Falls

2017-01-1413

Nathan A. Rose, Neal Carter, David Pentecost, and Alireza Hashemian

Kineticorp LLC

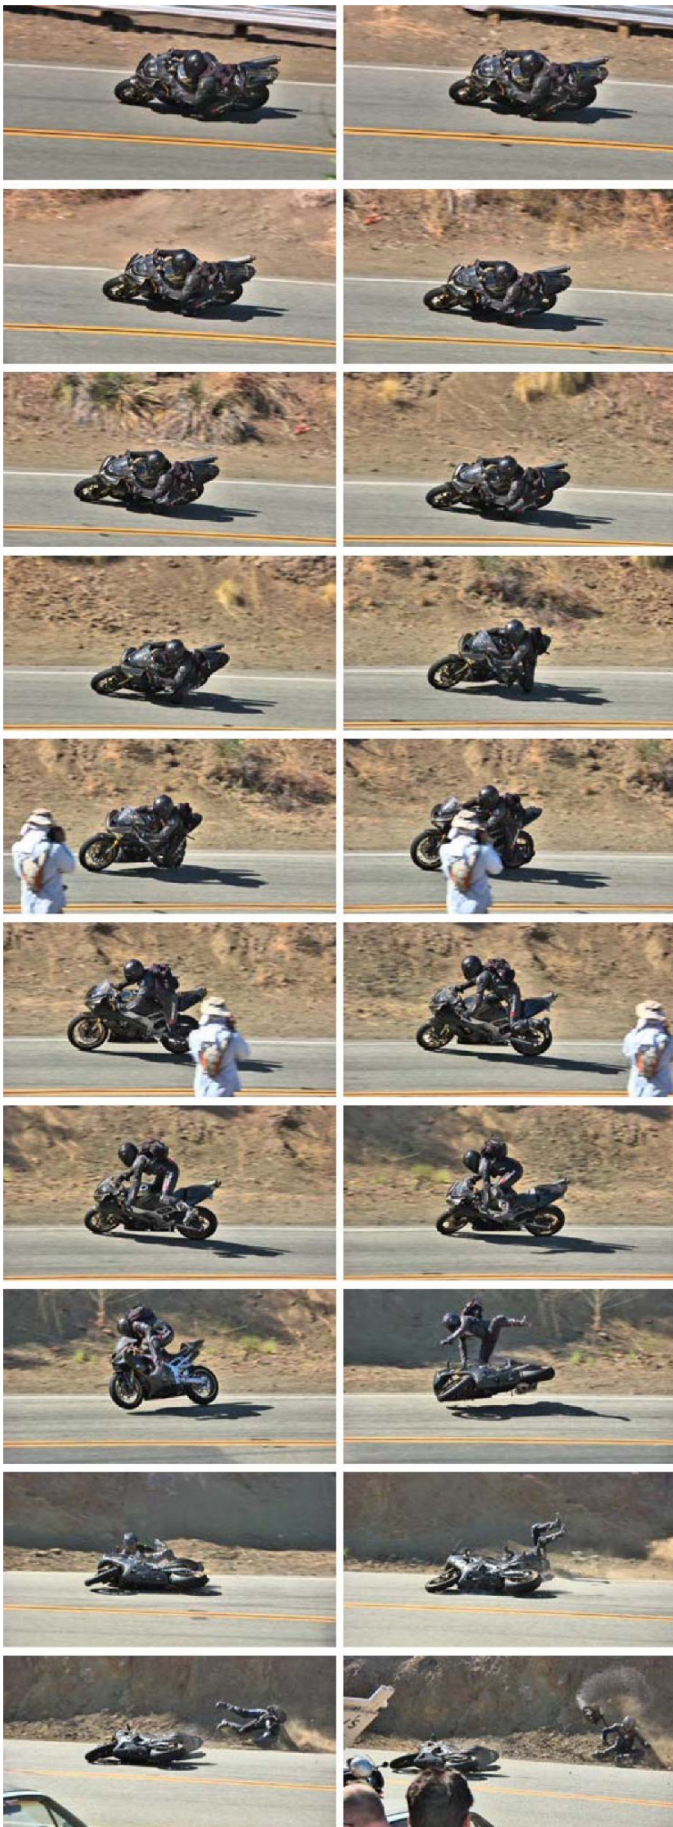
Figure 8. Video Sequence for Case #1

chosen so that Figure 8 would give the reader a sense for the motion of the motorcycle and rider during the loss of control and the fall. The frames of Figure 8 begin after the motorcyclist has driven into the curve and developed a leftward lean of the motorcycle and his body. This leftward lean developed over approximately 1.4 seconds. The frames of Figure 8 end after both the rider and motorcycle have struck the ground and they are both still in the process of sliding to rest.

Prior to the loss of control, the rider was applying his throttle throughout the curve. This throttle application was detectable in the audio from the video. The rider was also maintaining a relatively constant leftward lean angle up until the loss of control begins. The development of sideslip at the rear tire becomes evident in the video and the motorcycle begins yawing in a counterclockwise fashion. The sound from the video indicates that the development of this yaw was preceded by an increased engine rotation rate. The friction demanded by the acceleration and cornering exceeded the available friction, allowing the yaw to develop. As the motorcycle yaws, the rider's knee is pulled away from the motorcycle by its contact with the ground and his foot is pulled off the foot peg (Figure 10). The front wheel is steered to the right (also visible in Figure 10) and the rider rolls off the throttle. The motion of the rider's right hand on the throttle is visible approximately one third of a second after the development of sideslip at the rear tire becomes evident.

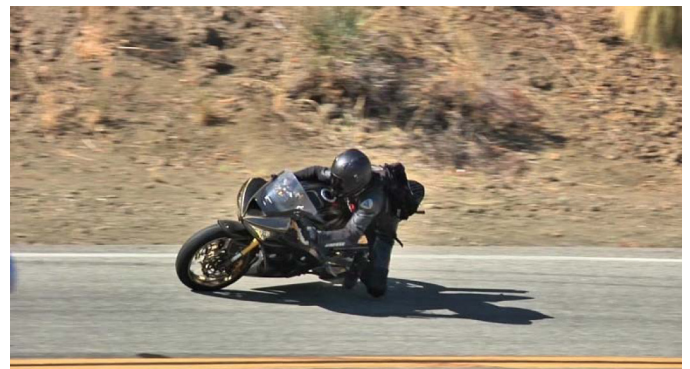
Figure 10. Contact with the Roadway Pulls the Rider's Left Knee Back and Pulls His Foot Off the Foot Peg

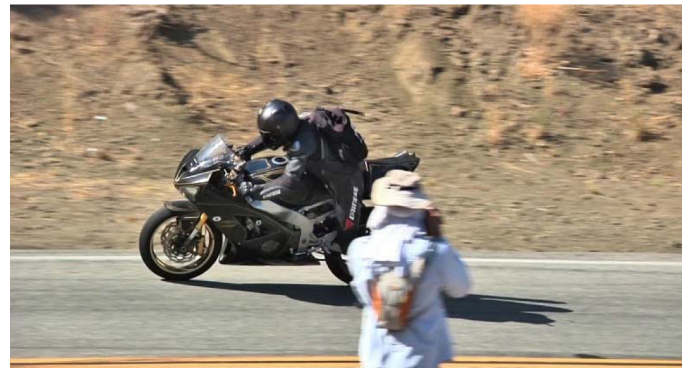
Figure 11. The Counterclockwise Yaw Ceases, the Motorcycle Yaws Clockwise and Rights Itself

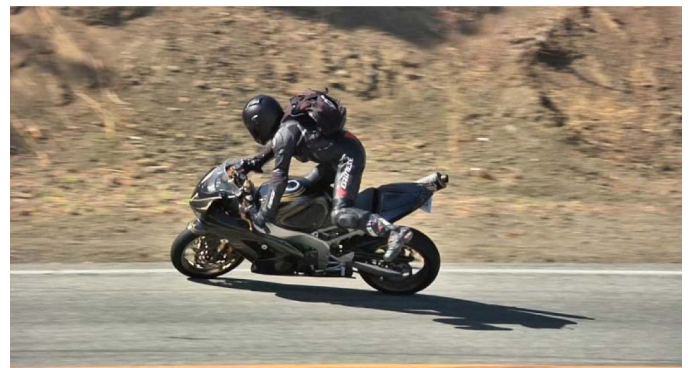
When the rider releases the throttle, the longitudinal force demand on the rear tire decreases and the available traction for cornering increases. This results in the leftward lean of the motorcycle beginning to decrease. Eventually, the counterclockwise yaw ceases and the motorcycle yaws clockwise as the motorcycle rights itself (Figure 11). As the heading of the motorcycle comes into alignment with its velocity direction and the motorcycle rights itself, the front tire is steered to the left (Figure 12). The momentum of the motorcycle initially continues to carry it towards a leftward lean/fall with a clockwise yaw rotation (also visible in Figure 12). A left leading sideslip develops. As this occurs, the rider's buttocks separate from the motorcycle (Figure 12).

Figure 12. Rider Steers to the Left, Motorcycle Initially Continues to Towards a Leftward Lean/Fall, and a Left Leading Sideslip Develops

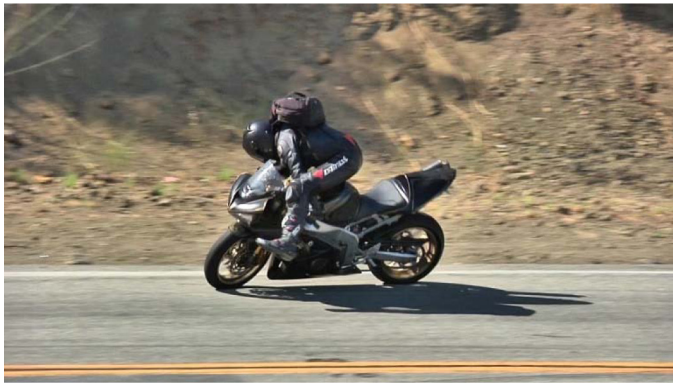
The leftward steer input reverses the yaw direction and the motorcycle again develops a right side leading sideslip (Figure 13). By this point in the sequence, the motorcycle speed has dropped to approximately 30 mph. The lateral force that develops during this right side leading sideslip throws the motorcycle into a rightward lean (Figure 14). As the motorcycle transitions from a leftward lean to a rightward lean, the motorcyclist's buttocks impact the fuel tank of the motorcycle. The motorcycle tires lose contact with the ground and the rider is projected upward, out ahead of, and to the right of the motorcycle (also visible in Figure 14). The rider initially continues to grasp the handlebar grips during this time, but eventually his trajectory and the motorcycle's diverge to the point that he releases his grip. From the position depicted in Figure 12 to the position depicted in Figure 14, the motorcycle and rider travel approximately 13 feet over 0.28 seconds.

Figure 13. Right Side Leading Sideslip

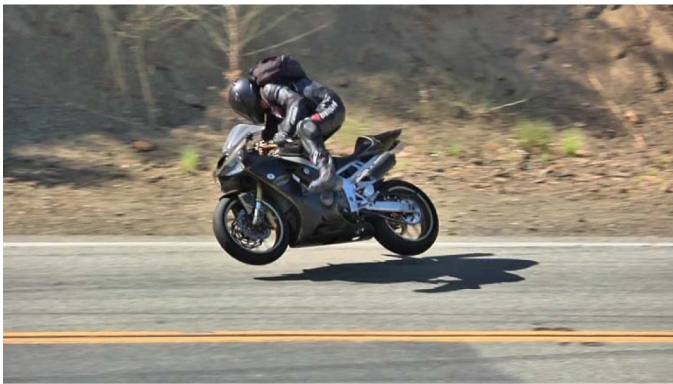
Figure 14. Lateral Force from Right Side Leading Sideslip Throws the Motorcycle into a Rightward Lean and Launches the Rider Ahead of the Motorcycle

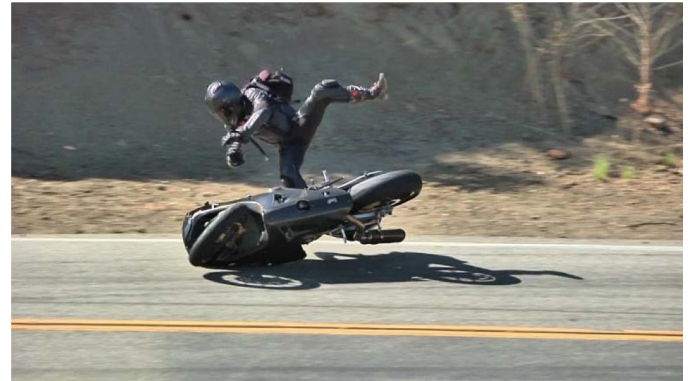
The motorcycle lands on its right side (Figure 15) and then the rider lands in a seated posture facing rearward, opposite his initial direction of travel, after a launch of 44 feet (Figure 16). The motorcycle remains on its right side while sliding on the ground for approximately 95 feet, decelerating at a rate of approximately 0.33g. The motorcycle does not tumble. As the rider travels to rest, his torso and head rotate toward the ground and ultimately strike it (Figure 17). He then tumbles heels-over-head and again comes to a seated posture striking the ground with his buttocks and legs and then flopping onto his back into the dirt shoulder. As a result of impacting the ground and then sliding and tumbling to rest, the rider decelerates at a rate of approximately 1.0g. This deceleration rate is consistent with the

Figure 15. Motorcycle Lands on Its Right Side

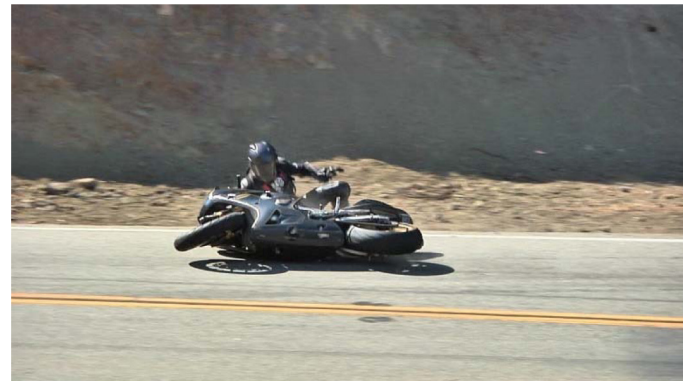
Figure 16. Rider Lands in a Seated Posture Facing Opposite His Initial Direction of Travel

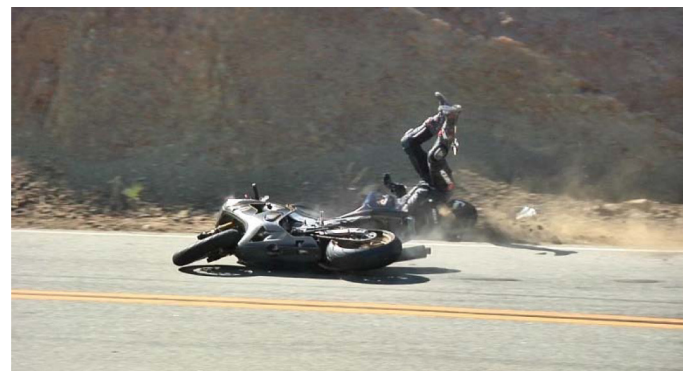
Figure 17. Rider Head and Torso Strike the Ground

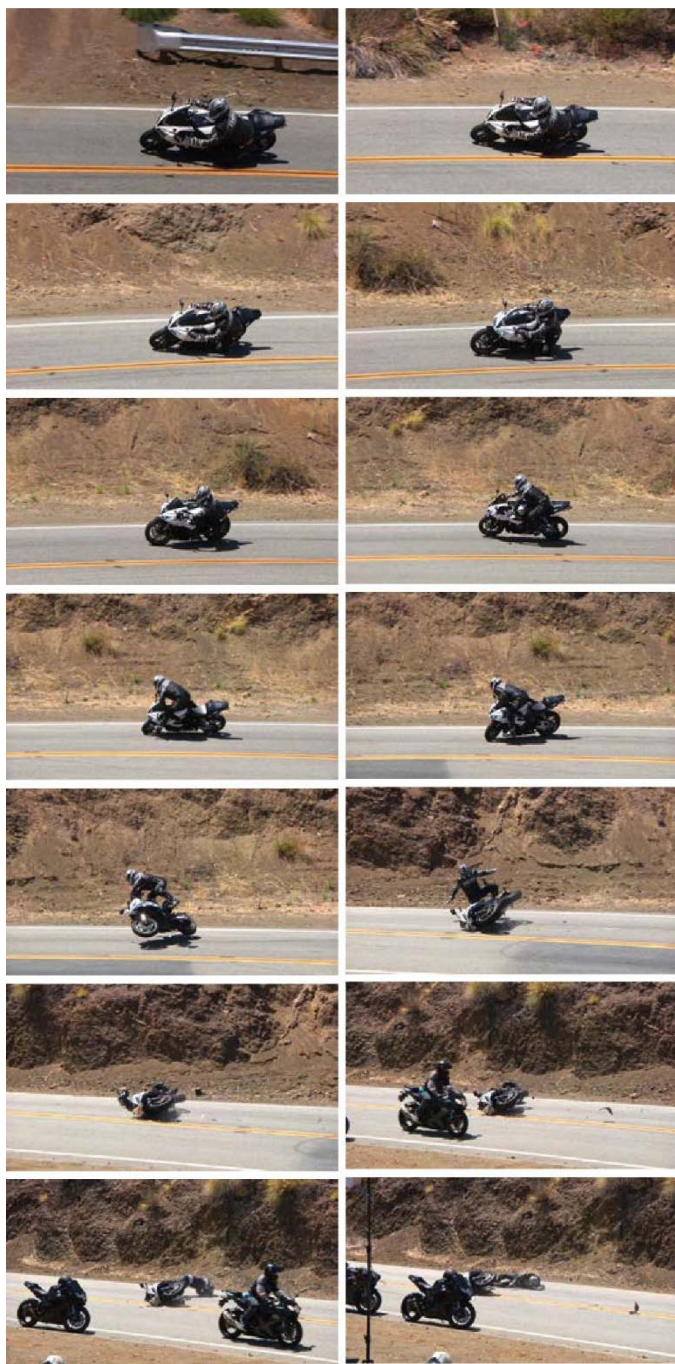
Figure 18. Video Sequence for Case #2

The frames of Figure 18 begin after the motorcyclist has driven into the curve and developed a leftward lean of the motorcycle and his body. This leftward lean developed over approximately 1 second. The

frames of Figure 18 end after both the rider and motorcycle have struck the ground and they are both still in the process of sliding to rest.

The tar marks and dark asphalt patches on the roadway were again used as reference points to determine travel distances. These are visible in the video frames of Figure 18. Calculations based on the distances traveled by the motorcycle between reference points and on the known frame rate of the video resulted in a speed for this motorcyclist as he approached the exit of the curve of approximately 43 mph. Prior to this, the rider had been applying throttle to increase his speed, as indicated by the audio. Beyond this point, the speed begins to decrease.

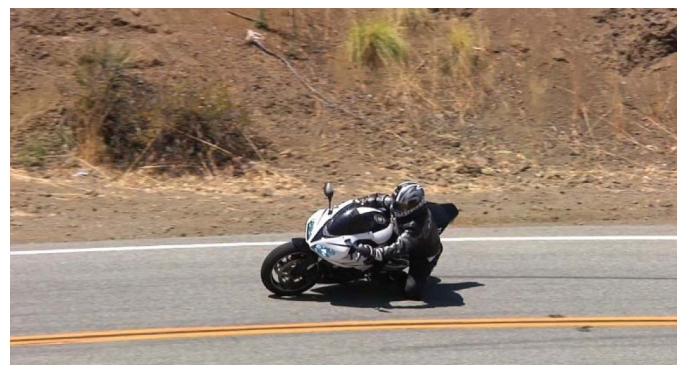
The development of right side leading sideslip at the rear tire becomes evident in the video and the motorcycle begins yawing in a counterclockwise fashion (Figure 19). During this yaw, the rear tire of the motorcycle deposits a tire mark on the roadway (visible in Figure 19). As the yaw progresses, the front wheel is steered to the right and the rider decreases the throttle input.

Figure 19. Right Side Leading Sideslip, Counter-Steer, and Tire Mark

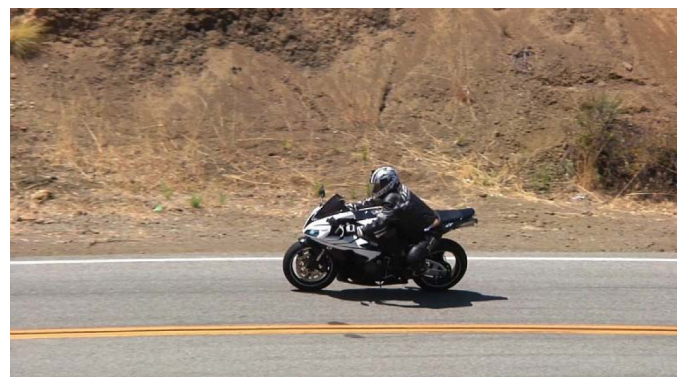
When the rider rolls off the throttle, the longitudinal force demand on the rear tire decreases and the available traction for cornering increases. This results in the leftward lean of the motorcycle beginning to decrease. Eventually, the counterclockwise yaw ceases and the motorcycle yaws clockwise as the motorcycle rights itself (Figure 20). The rear tire stops depositing a tire mark as the motorcycle comes back to vertical.

Figure 20. The Counterclockwise Yaw Ceases, the Motorcycle Yaws Clockwise and Rights Itself

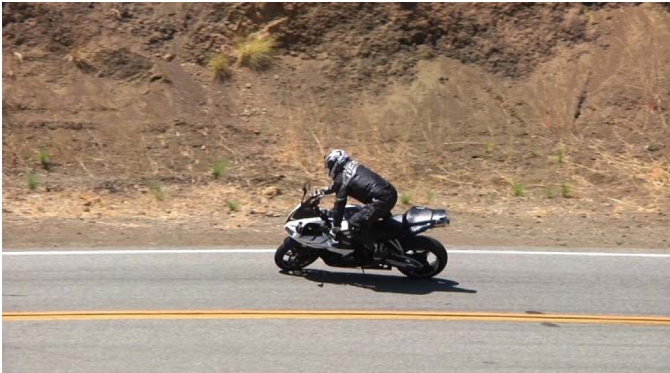
As the heading of the motorcycle comes into alignment with its velocity direction and the motorcycle rights itself, the front tire is steered to the left (Figure 21). The momentum of the motorcycle initially continues to carry it towards a leftward lean/fall with a clockwise yaw rotation (also visible in Figure 21). A left leading sideslip develops. As this occurs, the rider's buttocks separate from the motorcycle (Figure 21).

Figure 21. Rider Steers to the Left, Motorcycle Initially Continues to Towards a Leftward Lean/Fall, and a Left Leading Sideslip Develops

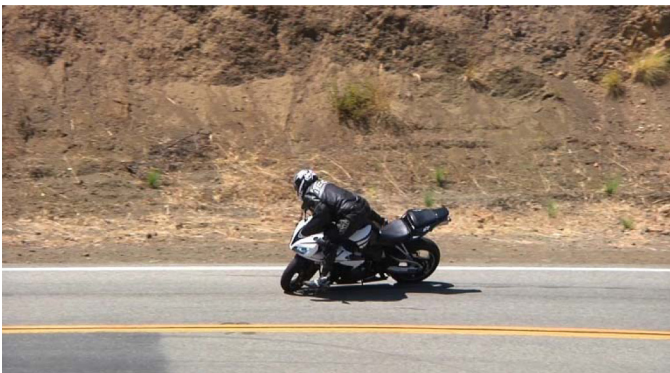
Eventually, the leftward steering reverses the yaw direction and the motorcycle again develops a right side leading sideslip (Figure 22). The rear tire of the motorcycle deposits a tire mark on the roadway and the lateral tire forces throw the motorcycle into a rightward lean (Figure 23). As the motorcycle transitions from a leftward lean to a rightward lean, the motorcyclist's groin and left thigh impact the fuel tank of the motorcycle. The motorcycle tires lose contact with the ground and the rider is projected upward, out ahead of, and to the right of the motorcycle (also visible in Figure 23).

Figure 22. Right Side Leading Sideslip

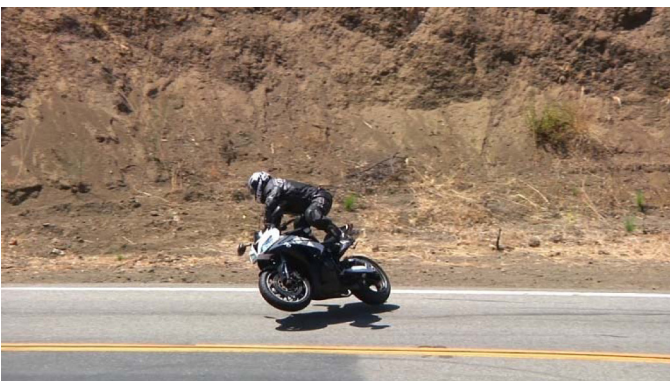
Figure 23. Lateral Forces from the Right Side Leading Sideslip Throw the Motorcycle into a Rightward Lean and the Rider is Launched Ahead of the Motorcycle

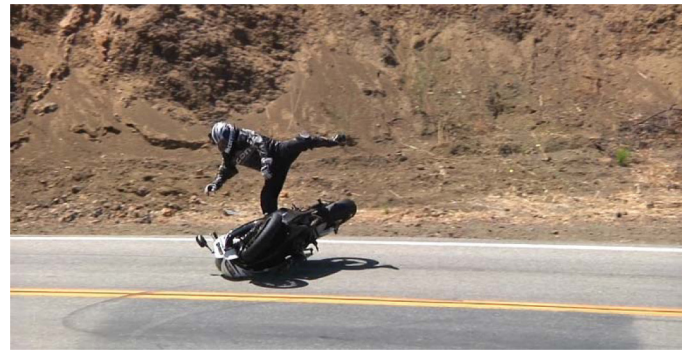
The motorcycle lands on its right side (Figure 24), and then the rider lands in a seated posture facing rearward, opposite his initial direction of travel (Figure 25). The rider was launched in the air a distance of approximately 54 feet. The motorcycle stays on its right side throughout its entire slide on the ground and does not tumble. It decelerates at an average rate of approximately 0.4g and then comes to rest on its right side facing opposite its initial direction of travel. As the rider travels to rest, his torso and head rotate toward the ground and ultimately strike it. He then tumbles to rest. As a result of impacting the ground and then sliding and tumbling to rest, the rider decelerates at a rate of approximately 1.07g, a rate higher than the rate at which the motorcycle decelerates. Because of this, the motorcycle comes to rest further down the road than the rider.

Figure 24. Motorcycle Lands on Its Right Side

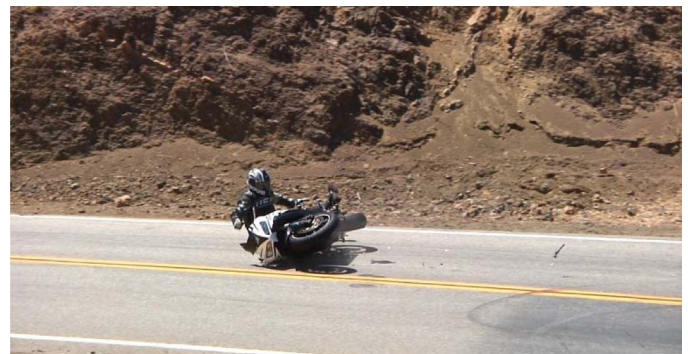
Figure 25. Rider Lands in a Seated Posture Facing Opposite His Initial Direction of Travel

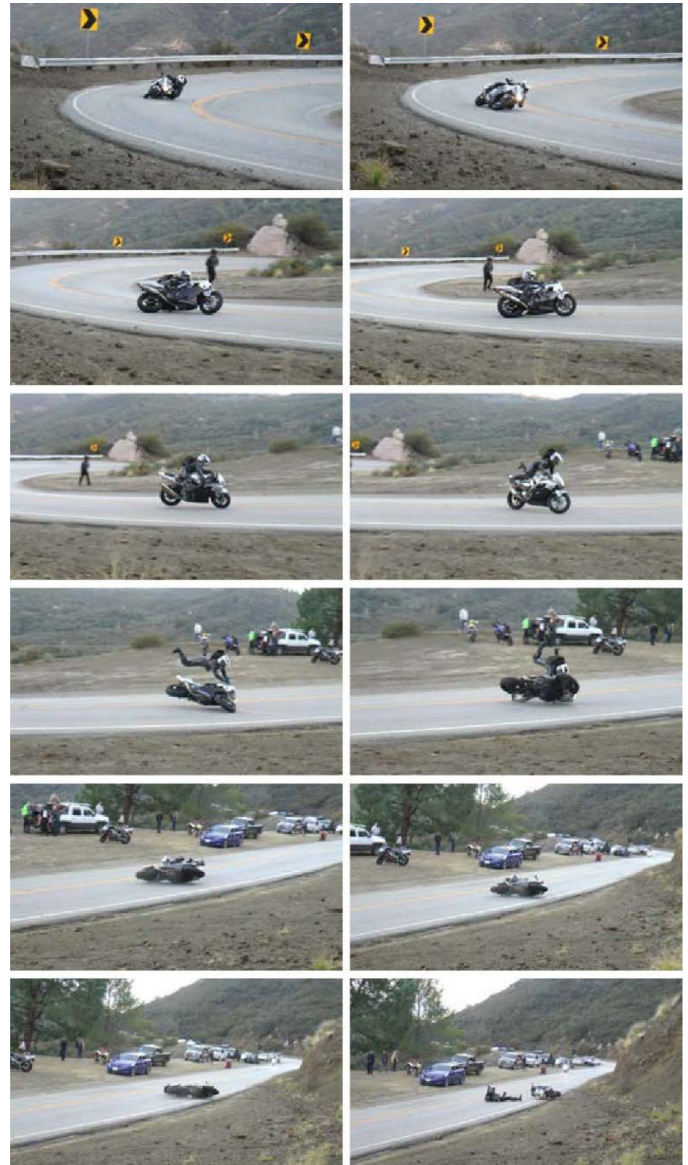
Figure 26. Video Sequence for Case #3

The third crash analyzed here involved a Honda CBR600 F4i (MY 2001) traveling westbound through Edwards Corner [11]. [Figure 26](#) contains a series of frames from the video showing the motorcycle and rider motion during this crash. The frame rate of this video was 59.94 frames per second. Again, the time intervals between these frames are not constant, but instead were chosen so that [Figure 26](#) would give the reader a sense for the motion of the motorcycle and rider during the loss of control and the fall. The frames of [Figure 26](#) begin after the motorcyclist has driven into the curve and developed a leftward lean of the motorcycle and his body. The frames of [Figure 26](#) end after both the rider and motorcycle have struck the ground and then slid to rest.

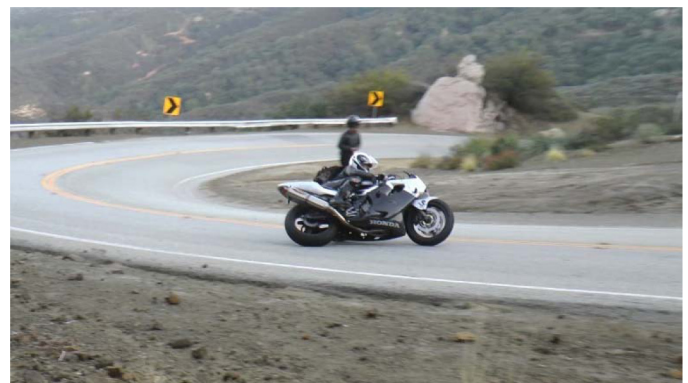
The tar marks and dark asphalt patches on the roadway were again used as reference points to determine travel distances. Travel distances were converted to speeds through the known frame rate. In this instance, the rider was traveling approximately 39 mph as he passed the end of the guardrail. A loss of traction occurs at the rear tire and the motorcycle enters a right side leading yaw ([Figure 27](#)). The front wheel is steered to the right (also visible in [Figure 27](#)).

Figure 27. Right Side Leading Sideslip and Counter-Steer

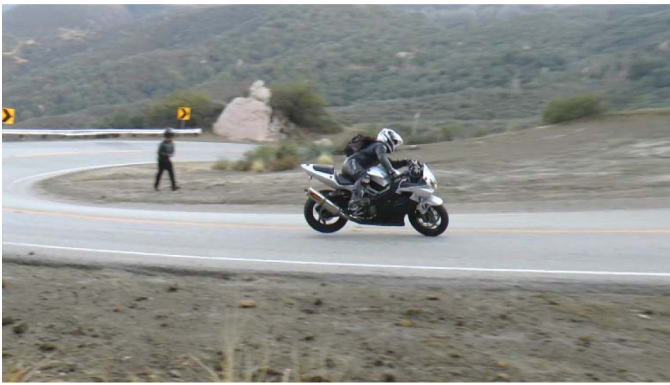
As this yaw develops, the engine speed remains relatively constant until shortly after the rider begins to counter steer. At that point, the engine speed rapidly decreases and the rear tire begins screeching as it slides across the pavement. When the screeching stops, the motorcycle quickly begins to roll into an upright position and to decrease its yaw angle ([Figure 28](#)).

In this instance, the rear tire leaves the roadway as the motorcycle rights itself (also visible in [Figure 28](#)). This leads to a quickly developing left side leading yaw that results in a left leading high-side fall when the rear tire lands ([Figures 29 and 30](#)). The rider is projected upward and forward relative to the motorcycle.

Figure 28. The Right Side Leading Yaw Ceases, the Motorcycle Yaws Clockwise and Rights Itself

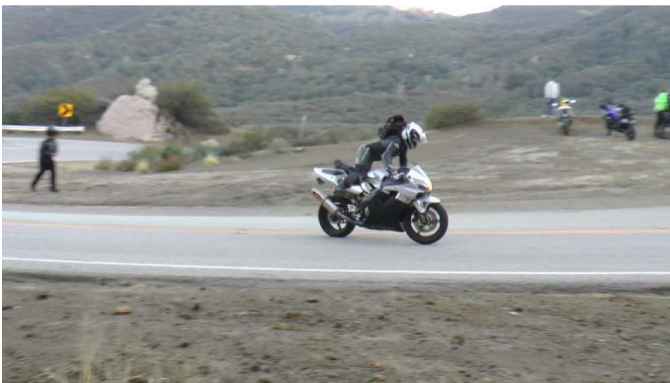
Figure 29. Left Side Leading Yaw

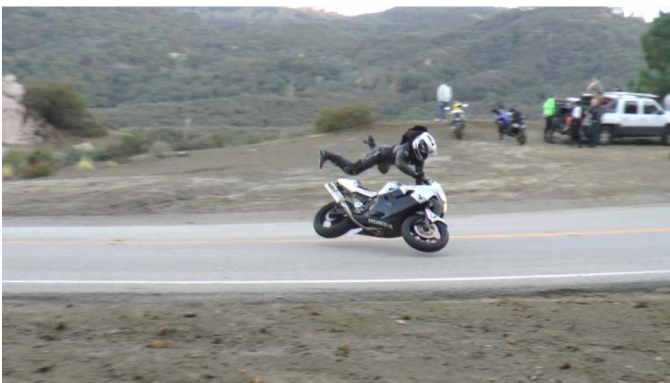
Figure 30. Left Side Leading High-Side Fall

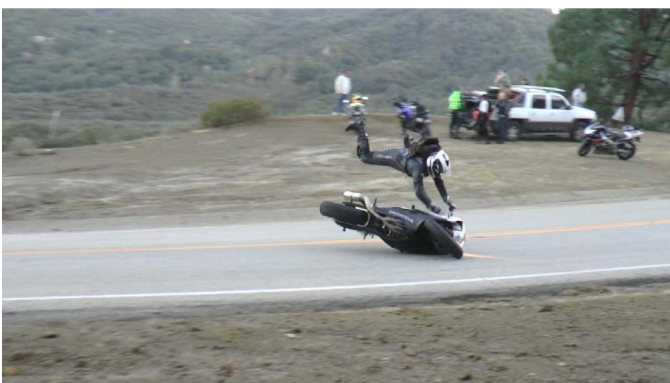
The motorcycle lands on its left side ([Figure 31](#)), while the rider is still airborne. Eventually, the rider lands feet leading, in a prone position having been thrown approximately 33 feet in the air. The motorcycle remains on its left side throughout its entire slide on the ground, decelerating at an average rate of 0.48g. After contacting the ground, the rider decelerates at a rate of 0.79g, higher than the motorcycle, and thus, during the sliding phase, the motorcycle catches up with and passes the rider. The motorcycle comes to rest just downstream of the rider, after sliding for approximately 52 feet.

Figure 31. Motorcycle Lands

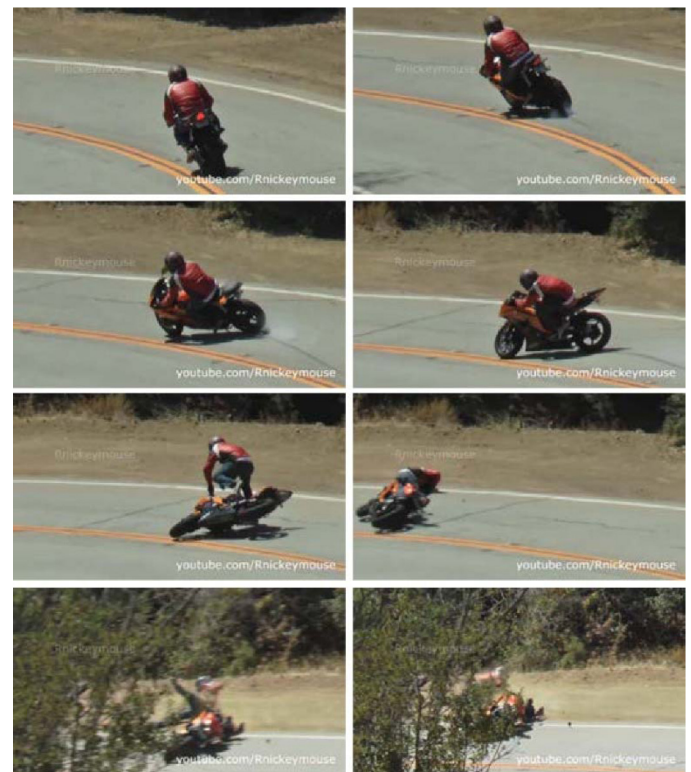
Figure 32. Video Sequence for Case #4

The rider in this crash had just traveled eastbound through Edwards Corner and was continuing down the hill when the video shows his motorcycle's chain coming off and beginning to drag on the ground. As the rider drives into the left turn immediately after Edwards Corner, the rear brake lamp becomes illuminated, indicating the rider has applied the brakes. The rider continues to brake as he enters the turn and develops a leftward lean. The rear tire of the motorcycle stops rotating and begins depositing a tire mark on the roadway. The vehicle's rear tire begins to off-track to the right and a right side leading yaw develops. The front tire is steered to the right and the

rider reduces the rear brake application. The available lateral traction increases and the motorcycle quickly transitions into a right side leading roll, vaulting itself and the rider into the air. The rider is projected out ahead of and to the right of the motorcycle. The motorcycle lands on its right side and slides to rest. The rider eventually lands and tumbles to rest.

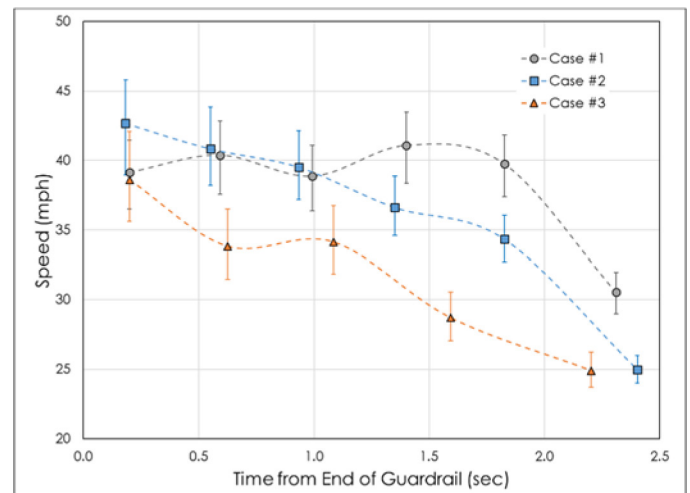
Figure 37. Speed Analysis Results

Figure 37 depicts the speed analysis results for Cases #1, #2, and #3. In these cases, the rider is requesting lateral tractive force from the rear tire to navigate the curve, while also requesting longitudinal tractive force by applying the throttle. Ultimately the resultant tractive force requested by the rider exceeds the available traction. Note that even though the riders are applying the throttle, due to the upward grade on this section of the roadway, the application of throttle does not necessarily result in a net increase in speed of the motorcycle, as seen in Cases #2 and #3.

To examine the sensitivity of the frames that we chose to represent the point at which the motorcycles passed each tar mark, the number of frames between each consecutive pair of positions was varied and the effect that the variance had on the calculated speeds was determined. For Case #1 and Case #2, the times were varied by $1\frac{1}{2}$ frames (0.025 seconds), which resulted in a speed variance of approximately ± 3 mph or less for each calculated speed. For Case #3, the camera angle was less conducive to a precise estimate of the motorcycle position, so the time component of the speed calculation was varied by 2 frames (0.033 seconds), which resulted in a speed variance of approximately $\pm 3\frac{1}{2}$ mph or less. The vertical bars in Figure 37 represent the results of the sensitivity analysis.
