Performance of Event Data Recorders Found in Toyota Airbag Control Modules in High Severity Frontal Oblique Offset Crash Tests

William Bortles Kineticorp, LLC.

Citation: Bortles, W. and Hostetler, R., "Performance of Event Data Recorders Found in Toyota Airbag Control Modules in High Severity Frontal Oblique Offset Crash Tests," SAE Technical Paper 2019-01-0633, 2019, doi:10.4271/2019-01-0633.

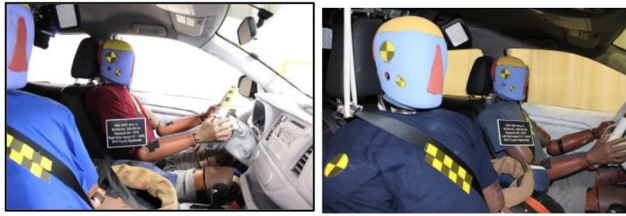
FIGURE 10 Occupant/Dummy Photographs (Test #9480 - Left, Test #9481 - Right)

In both tests, one 50% adult male THOR-NT anthropomorphic test device (ATD) was seated in the left front (driver) seating position, and one 50% adult male THOR-NT anthropomorphic test device was seated in the right front passenger seating position. Both of the ATDs were properly restrained with lap and shoulder belts, as seen in Figure 10. The EDR in the Toyota ACM correctly reported the safety belt status for both occupants. The EDR in the Toyota ACM also correctly reported the front passenger Occupant Size Classification as “AM50 (Not Child).” Excerpts from the EDR reports are shown in Figure 11.

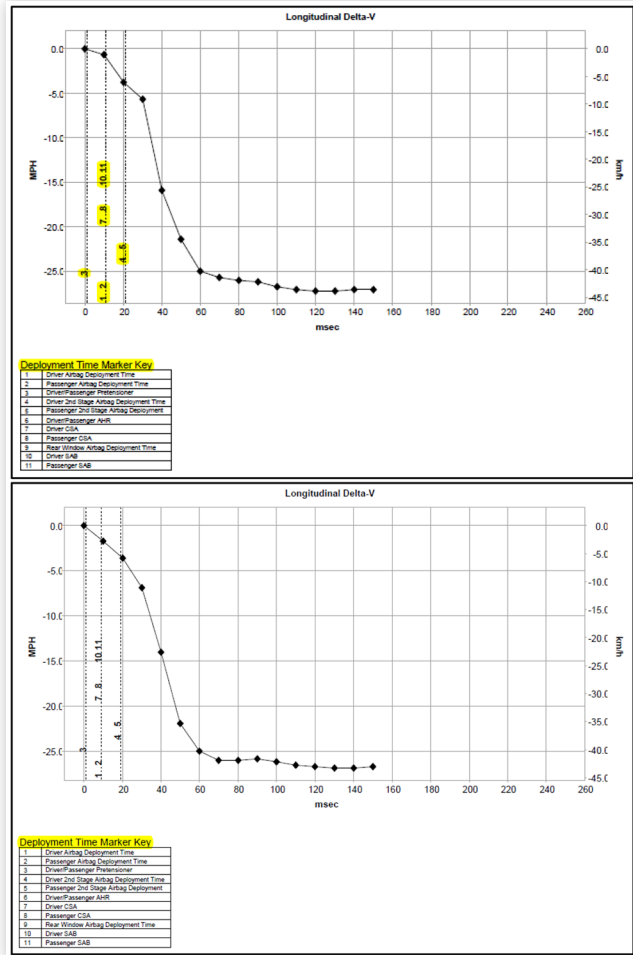
FIGURE 12 EDR Report Excerpt: Deployment Time(s) and Crash Pulse (Test #9480 - Top, Test #9481 - Bottom)

Figure 12 contains a sample from the EDR report in which the deployment commands are plotted along with the crash pulse for various event triggers. These deployment times are also explicitly stated in “System Status at Event” tables corresponding to each event in the EDR report.

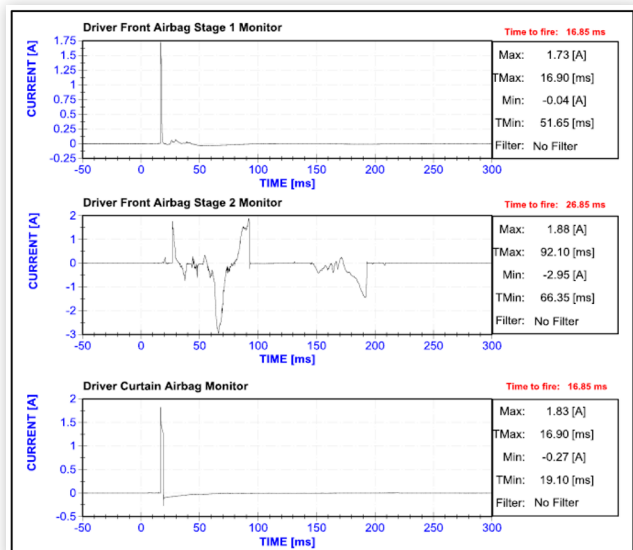
FIGURE 13 Reference Instrumentation Excerpt: Restraint Monitor (Test #9480)

For these crash tests, an external sensor was installed that monitored electrical current versus time, and a “time to fire” was reported for various supplemental restraints. Figure 13 contains a sample of the data plots monitoring electrical current versus time for these restraint signal monitors. The “Time to fire” is listed in red in Figure 13.

Figure 13 is an example of reference instrumentation electrical current, versus time plots which report “Time to fire” for various restraints within the vehicle. This “Time to fire” is relative to contact between the two vehicles and the closing of a tape switch mounted in the contact zone.

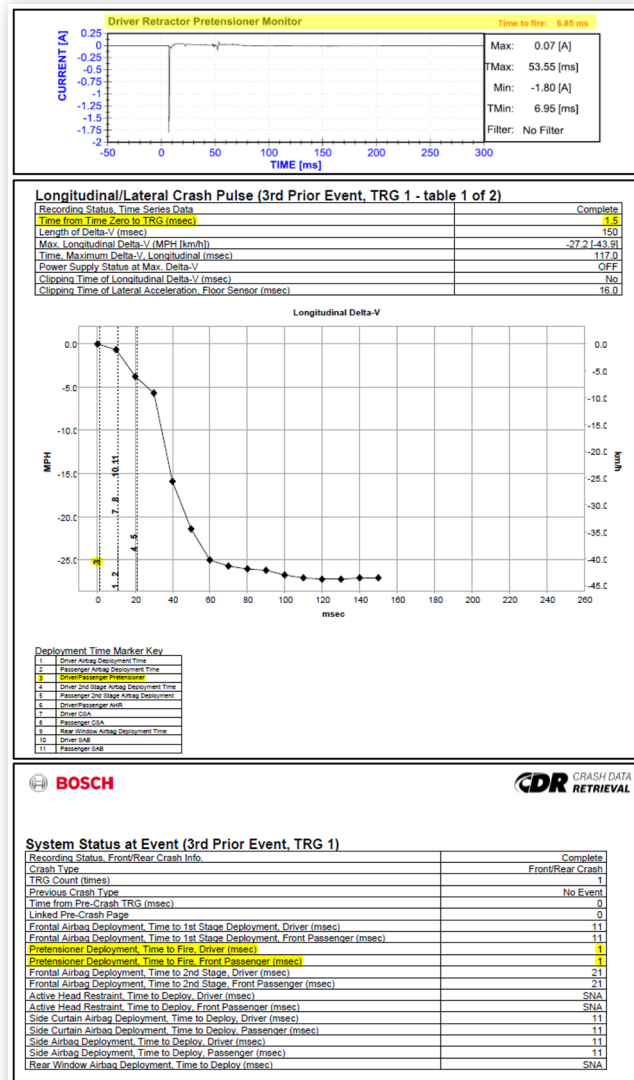
FIGURE 14 Example Calculation: Alignment Time (Test #9480)

Figure 14 contains excerpts from the reference instrumentation and the EDR report that exemplify the calculation of the alignment time for test 9480.

$$t_{\text{alignment}} = t_{\text{deployment,ref}} - (\text{Time Zero to TRG}_{\text{EDR}} + t_{\text{deployment,EDR}}) \quad [1]$$

$$t_{\text{alignment}} = 6.85 \text{ ms} - (1.5 \text{ ms} + 1 \text{ ms})$$

This “alignment time” was calculated for each restraint deployment command from the EDR report and its corresponding deployment time from the reference instrumentation. This alignment time was calculated as 4.35 milliseconds for Test #9480 and 4.15 milliseconds for Test #9481.

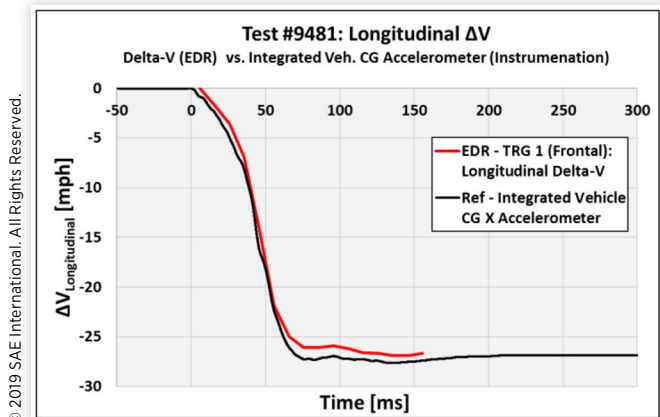
FIGURE 16 Longitudinal Delta-V (Test #9481)

As seen in Figure 15 and Figure 16, the longitudinal ΔV reported by the EDR slightly underreports the reference instrumentation. The error for each test is:

- Final $\Delta V_{Long.}$ Error: 0.2 km/h (0.1 mph)
 - Final $\Delta V_{Long.}$ Percent Error: -0.5%
- Test #9481
 - EDR Reported Max. $\Delta V_{Long.}$: -43.3 km/h (-26.9 mph)

- Reference Max. $\Delta V_{Long.}$: -44.5 km/h (-27.6 mph)
 - Max. $\Delta V_{Long.}$ Error: 1.2 km/h (0.74 mph)
 - Max. $\Delta V_{Long.}$ Percent Error: -2.7%

- EDR Final $\Delta V_{Long.}$: -43.0 km/h (-26.7 mph)
 - Reference Final $\Delta V_{Long.}$: -44.1 km/h (-27.4 mph)
 - Final $\Delta V_{Long.}$ Error: 1.1 km/h (0.71 mph)

- Final $\Delta V_{Long.}$ Percent Error: -2.6%

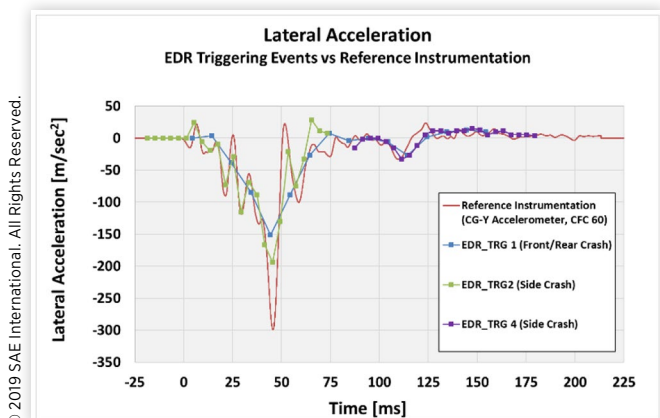
FIGURE 16 Lateral Crash Pulse from Frontal and Side Crash Events (Test #9480)

Figure 16 contains a plot of the reference instrumentation lateral acceleration, versus the EDR reported lateral acceleration pulse for the Front/Rear (TRG 1) and Side Crash (TRG 2 and TRG 4) events for test #9480. The shape of the EDR reported lateral crash pulse generally correlates to the reference instrumentation but underestimate the peak accelerations.

As seen in Figure 16, the peak acceleration of approximately -300 m/sec^2 (-30.5 g) occurred at approximately 45 ms and a second, localized peak of approximately -33 m/sec^2 occurred at approximately 110 ms. TRG 1 and TRG 3 captured

the general shape of the pulse but underreported the peak lateral acceleration by a percent error of approximately 49% and 35%, respectively. TRG 1 and TRG 4 also captured the general shape of the second, localized peak but underreported the lateral acceleration by a percent error of 19% and 1.4% respectively. This could be a result of sampling frequency, as the reference instrumentation records at 20,000 Hz, whereas the EDR reports lateral accelerations at 100 Hz for Front/Rear Crashes and 250 Hz for Side Crashes.

For Test #9480, due to the reporting rate, the magnitude of the peak lateral acceleration was underreported and the calculated lateral ΔV underestimated the reference instrumentation by 14.6% to 18.3%.

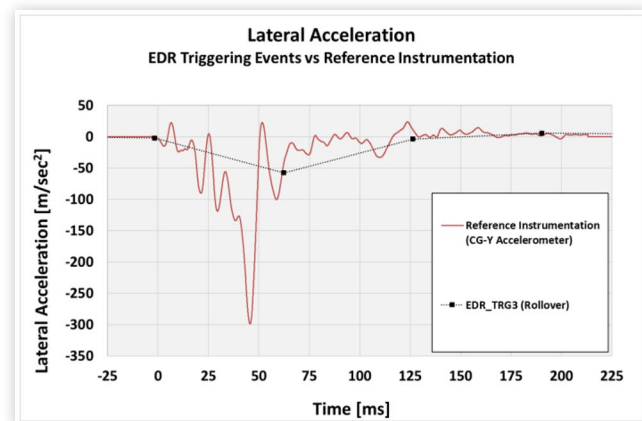
FIGURE 17 Lateral Crash Pulse from Rollover Event (Test #9480)

Figure 17 contains a plot of the lateral acceleration associated with the Rollover event (TRG 3). The lateral crash pulse from this trigger was reported by the EDR at approximately 15.6 Hz, or every 64 ms. At this reporting frequency, the peak acceleration was not captured. The percent error for this peak acceleration from TRG 3 was approximately -81%.

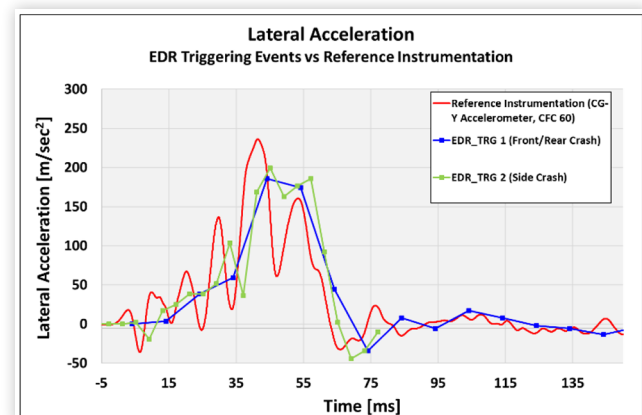
FIGURE 18 Lateral Crash Pulse from Frontal and Side Crash Events (Test #9481)

Figure 18 compares the EDR reported lateral accelerations to the reference instrumentation for Test #9481. As seen in Figure 18, the peak acceleration of approximately +235 m/sec² occurred at approximate 40 ms. TRG 1 (Front/Rear Crash) and TRG 2 (Side Crash) captured the general shape of the pulse, but underreported the peak lateral acceleration by a percent error of approximately 21% and 16%, respectively. As stated earlier, the Rollover event from crash test #9481 was not completely captured and did not report any lateral acceleration data.

For Test #9481, the reporting rate also lead to underreporting of the magnitude of the peak lateral acceleration. However, aliasing¹ resulted in the overreporting of the calculated lateral ΔV by 4.8 to 7.8%, as seen in Figure 17.
