Video Analysis of Motorcycle and Rider Dynamics During High-Side Falls

2017-01-1413

Nathan A. Rose, Neal Carter, David Pentecost, and Alireza Hashemian

Kineticorp LLC

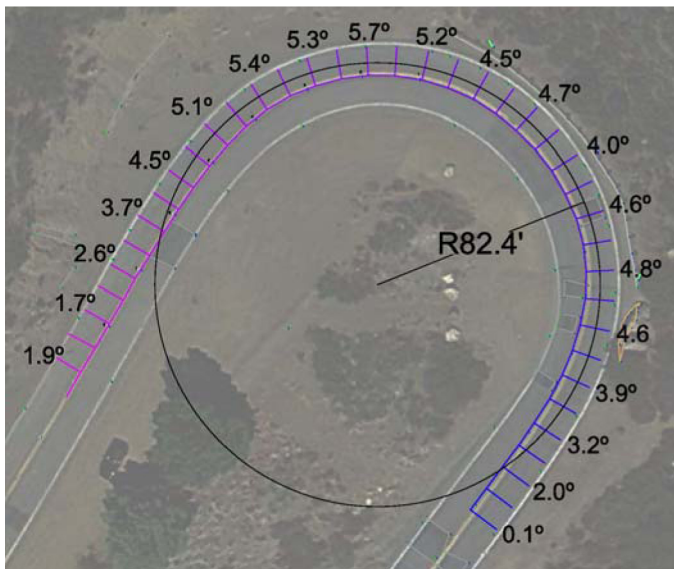
Figure 7. Slopes and Cross-Slopes for Edwards Corner

The survey and scan data from this site inspection was used to quantify the geometry of the subject curve, in terms of its radius, slope, and cross-slope ([Figure 7](#)). Riders traveling westbound through Edwards Corner encounter a left hand curve with an upslope. During the first half of the curve, the upslope is approximately 3.2 degrees and during the second half it is 4.9 degrees. There is a total elevation gain of 27.6 feet over a 390.8-foot distance around the curve. At the westbound entry to the curve, the cross-slope is negligible. It increases to a maximum cross-slope of 5.7 degrees (with the inside of the curve being lower than the outside). The cross-slope then begins to decrease again, reaching a value of 1.9 degrees at the exit to the curve. The radius of the curve in the center of the westbound lane is approximately 82 feet. Given the radius and cross-slope, a rider traveling through this curve at a speed in the range of 35 to 45 mph would need a leftward lean in the range of 40 to 55 degrees relative to the roadway while traversing the curve [[6,7](#)].

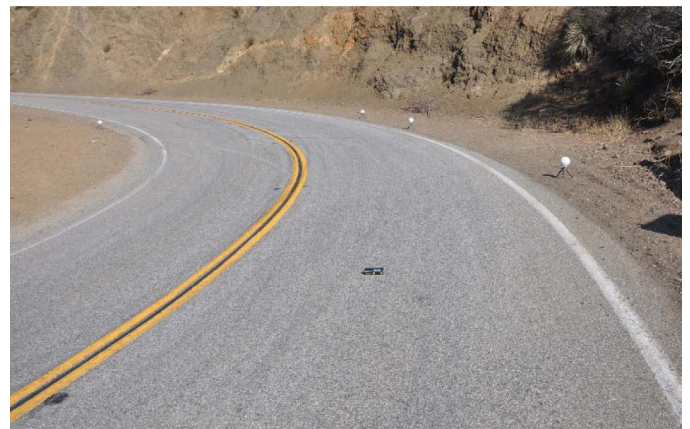
Figure 9. Examples of Tar Marks used for Reference Points in Video Analysis

In quantifying the speeds and motion of the motorcycle and rider in this video (and the other videos discussed later), tar marks and dark patches of asphalt were used as reference points to determine travel distances. These are visible in the video frames of Figure 8 (the tar marks straddle the centerline). Also, Figure 9 is a photograph from the authors' site inspection in which some of the tar marks are also visible. The locations of these tar marks and dark patches were documented during our site inspection. Calculations based on the distances traveled by the motorcycle between these reference points and on the known frame rate of the video revealed that this motorcyclist was traveling a speed of approximately 40 mph as he approached the exit of the curve, a speed that is maintained until the rider begins losing control of the motorcycle.

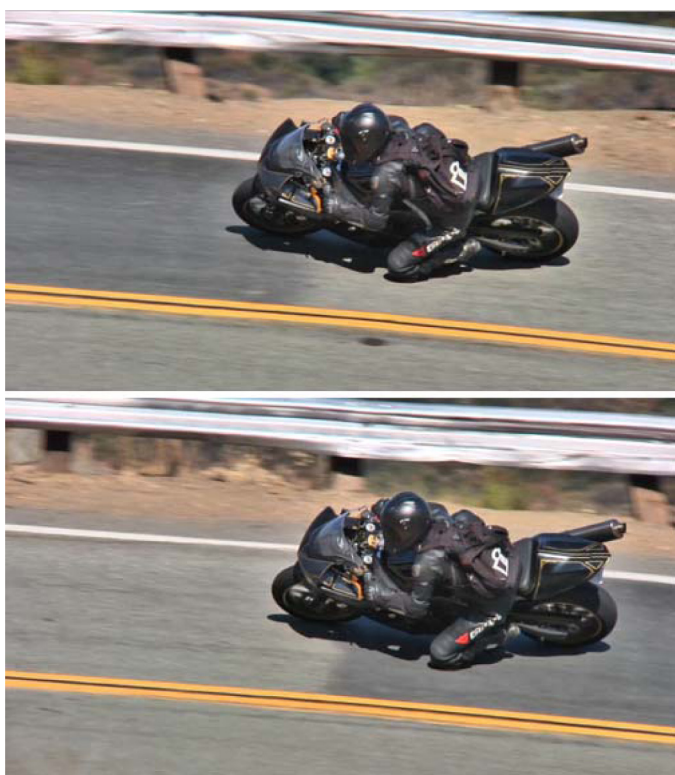
Figure 33. Frames from Case #1 Used for Audio Analysis

As a check on the speeds obtained through the visual video analysis, audio data from the video was also analyzed for Case #1. This analysis was conducted during the timeframe when the motorcycle and rider were traversing the curve prior to losing control. [Figure 33](#) contains two frames of the video for Case #1. These frames depict the beginning and ending of the timeframe over which we conducted audio analysis. This timeframe was chosen because the motorcycle traverses a dark patch in the asphalt that was both visible in the video and mapped during our site inspection.

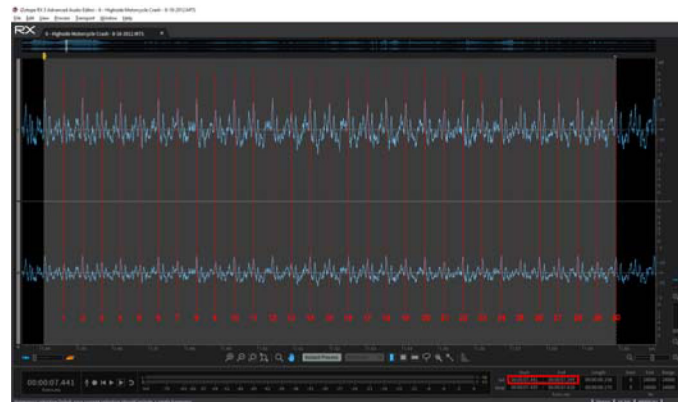
Figure 34. Audio Analysis, Case #1

To conduct our audio analysis, we imported the video file from Case #1 into RX 5 Audio Editor [13] to analyze the left and right waveforms. This revealed a cyclical pattern from the sound of the motorcycle engine. The number of cycles were counted for the segment of audio in which the rider traversed the dark patch in the asphalt, as depicted in [Figure 34](#). This led to the conclusion that the cyclical pattern occurred at a frequency of 190 Hz. A four-cylinder, four-cycle engine will produce two exhaust notes for every rotation of the engine. So the engine would be rotating at $\frac{1}{2}$ the frequency of the cyclical pattern in the sound. Thus, we determined that the engine was rotating at a rate of approximately 5700 RPM.

We obtained drivetrain specifications for the motorcycle, and determined the speed that the motorcycle would be travelling in various gears at an engine speed of 5700 RPM [14]. After the crash, the camera operator records the condition of the motorcycle, and the rear sprocket is shown. We determined that the rear sprocket was an aftermarket Vortex sprocket, but that it was only available with the stock number of teeth. The front countershaft sprocket was not visible, so it's possible that an aftermarket front sprocket would change the final drive ratio. We assumed the factory drive ratio and determined that in 1st, 2nd, 3rd, and 4th gear, the motorcycle would be travelling at 26.7, 37.9, 45.2, and 53.7 mph, respectively. The analysis of the video over these two frames resulted in a speed of 37.0 mph for motorcycle, and therefore, we concluded that the motorcycle was in 2nd gear during this section.

The audio analysis coupled with the drivetrain analysis performed on Case #1 resulted in a motorcycle speed above that found using video-frame analysis, 37.9 vs 37.0 miles per hour. This discrepancy can be explained via the difference in theoretical rolling radius of a new vertical tire used in the computation and the actual rolling radius that is reduced due to the subject motorcycle's lean angle, tire-contact patch deformation, longitudinal slip percentage, and tread depth.
